NDI No. PA 01069
PENN DER No. 10-26

TREESDALE FARM DAM

PHASE I INSPECTION REPORT
NATIONAL DAM INSPECTION PROGRAM

MARCH 1981

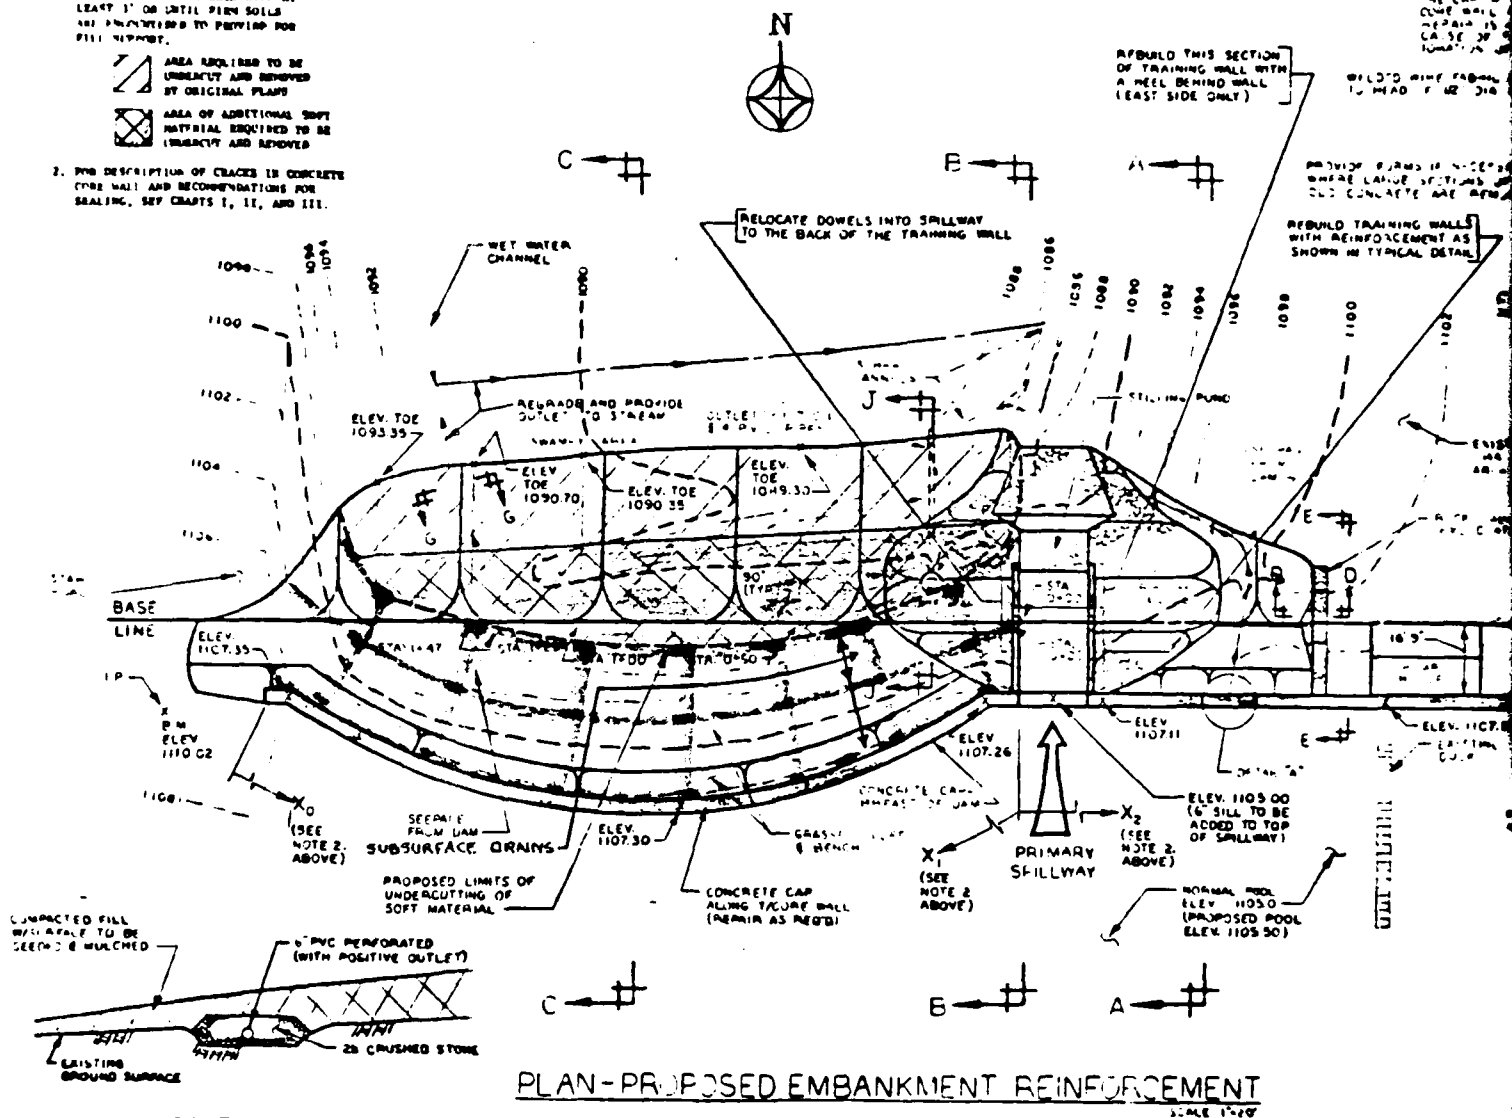
AREA OF ADDITIONAL SOFT MATERIAL REQUIRED TO BE EXCAVATED AND REMOVED

2. THE DESCRIPTION OF CRACKS IN CONCRETE TYPE WALL AND RECOMMENDATIONS FOR SEALING, SEE CHARTS I, II, AND III.

1. AREA SHOWN TO BE EXCAVATED AT LEAST 1' OR UNTIL FIRM SOILS ARE ENCOUNTERED TO PREPARE FOR FILL REPAIRS.
